TO: County Commission  
FROM: Robert W. Wilson  
Date: November 3, 2023  
Subject: RDJ Building Inspection Report

## Robert D Johnson Building Inspection Fargo, North Dakota

**Building Condition Report**

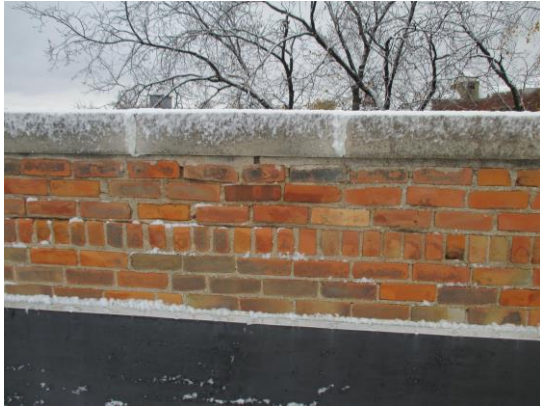
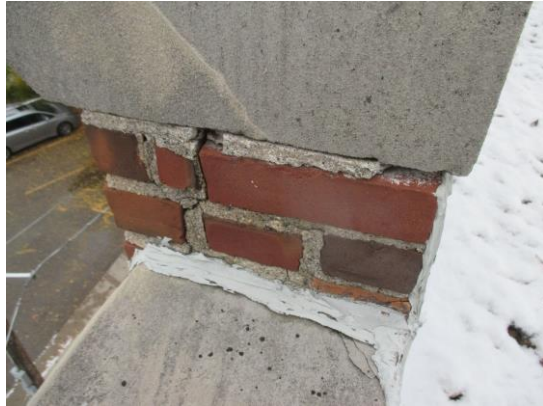
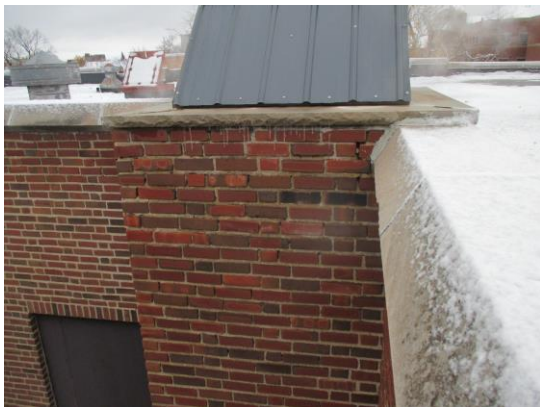
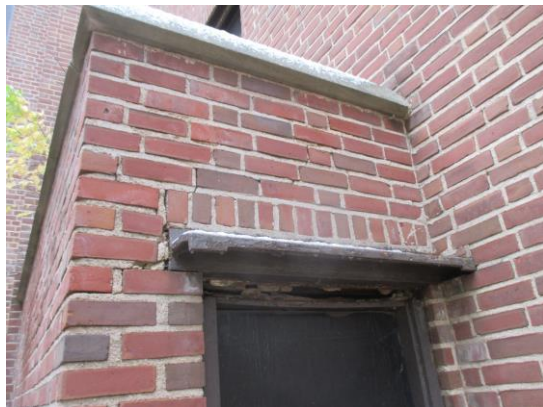
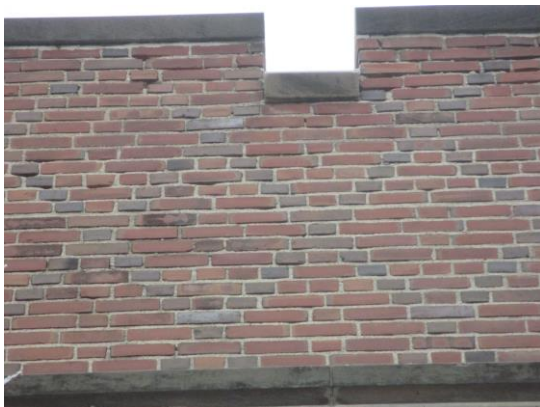
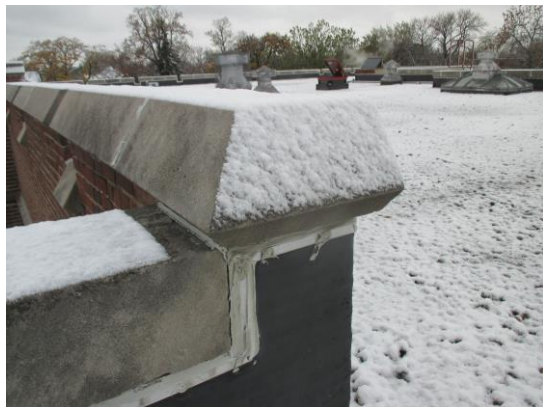
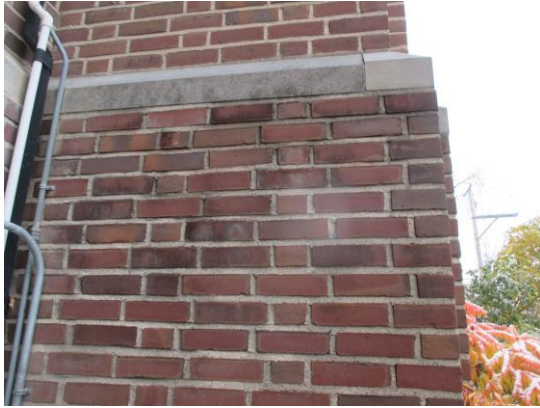
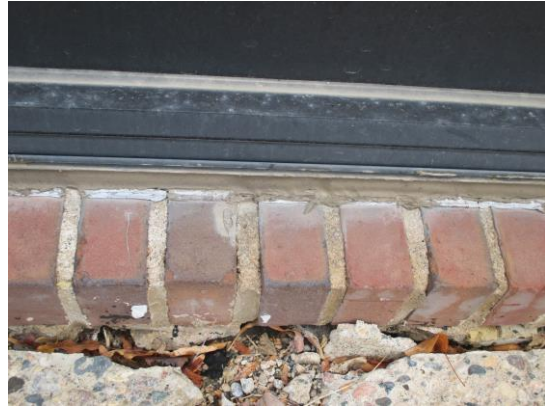
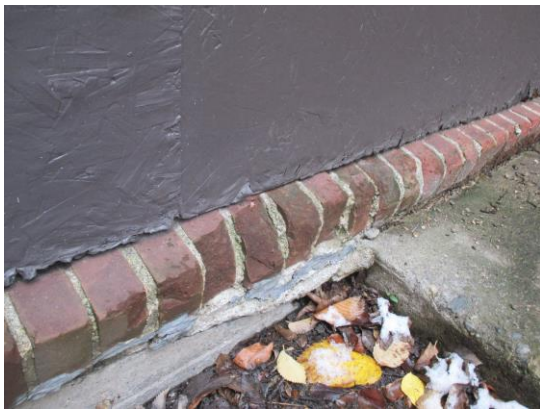
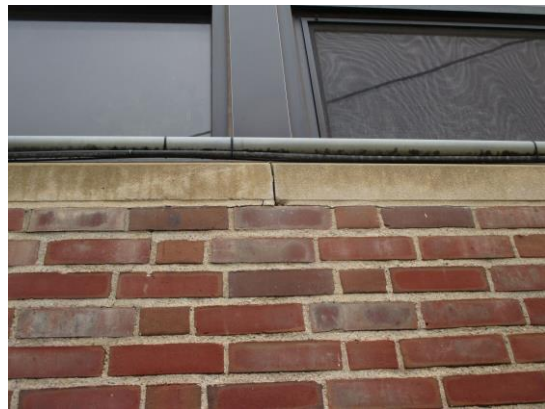
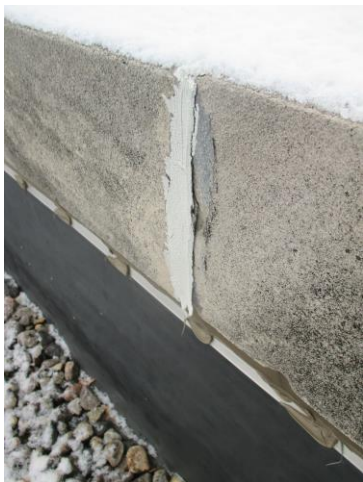
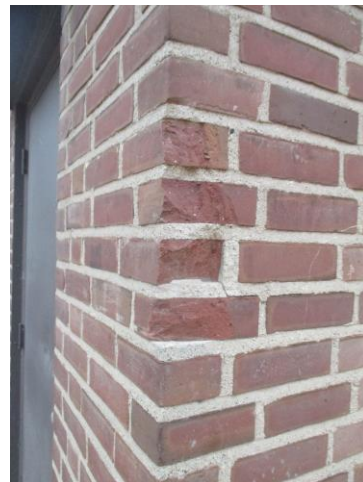
1. Overall the exterior finishes are in good condition with no major cracking or failures that may be indicative of hidden structural issues.
2. There are various locations around the building where the mortar has deteriorated to the point of needing repair, especially along the parapets, window sills and chimney. Openings in the mortar allow moisture to infiltrate the walls that could lead to further wall deterioration and interior finish damage. Recommend a 100% building cleaning and tuckpointing equating to about 10%-15% of entire building elevation.

3. Caulking at the head joints at the stone cap along the top of the roof parapet has pulled away from surfaces and should be replaced.
4. The mortar at the head joints of the stone banding is missing or deteriorated in the majority of locations allowing moisture to infiltrate the wall system. These should be replaced with flexible sealant.

A1: Back of east parapet

A2: Notch in parapet.

A3: Chimney

A4: Door head in courtyard.

A5: Face of east parapet

A6: Head joint at window sill

A7: Deteriorated mortar joints

A8: Window sill along grade.

A9: Window Sill

A10: Window sill.

A11: Sealant joint

A12: Damaged brick at courtyard

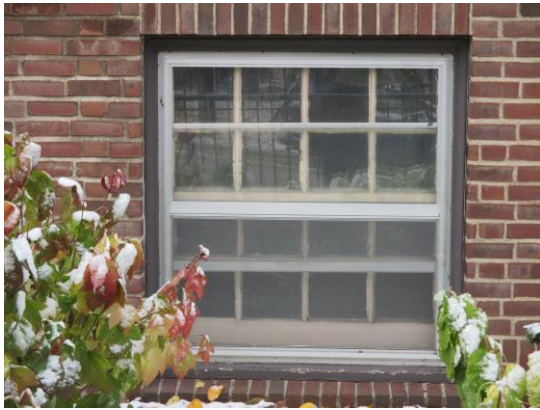
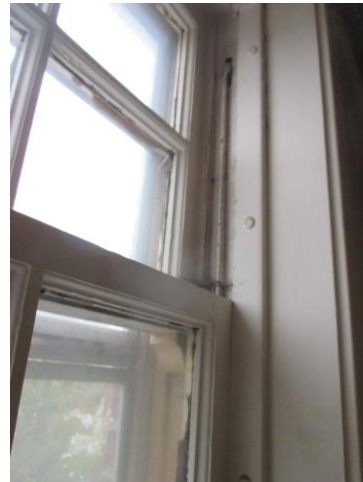
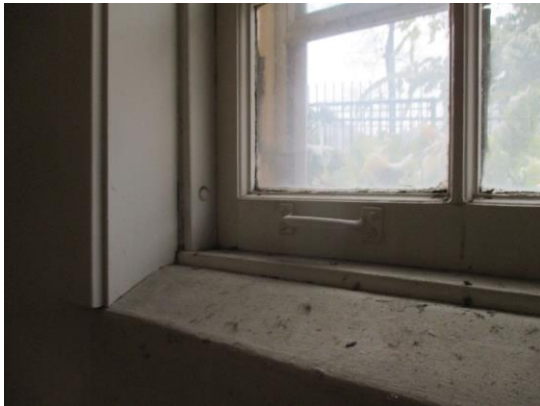
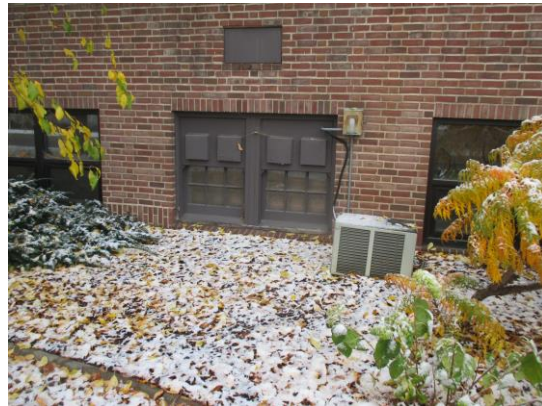
1. For the age of windows, no major deterioration was observed.
2. Replacements could be considered to match other openings replaced and would increase energy efficiency.
3. Refinishing and recaulking should be completed in next 3-5 years.

A13: Existing window exterior

A14: Existing window interior.

A15: Existing window Interior

A16: Existing Window Exterior.

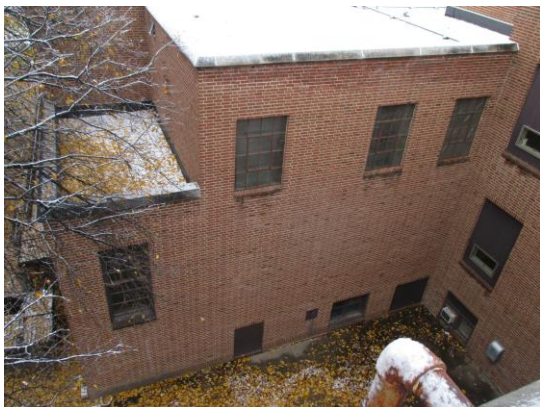
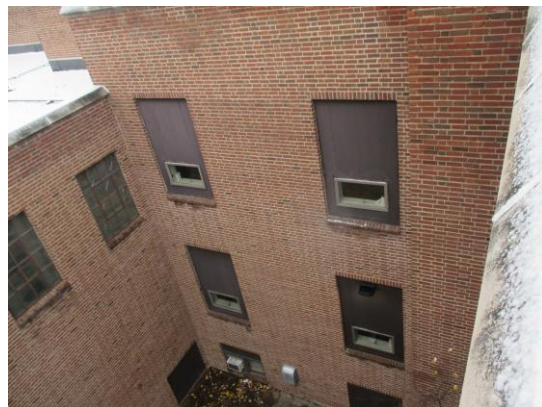
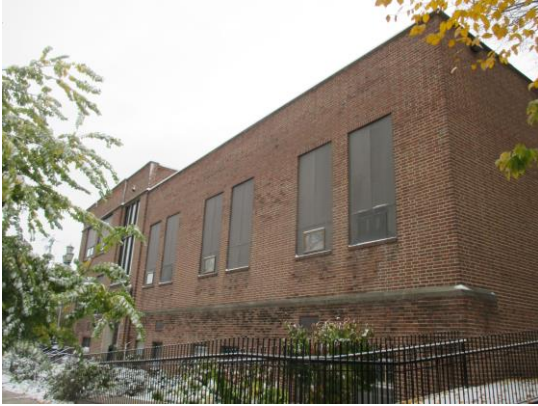
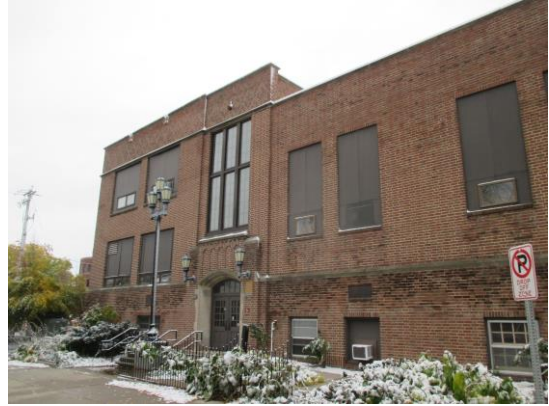
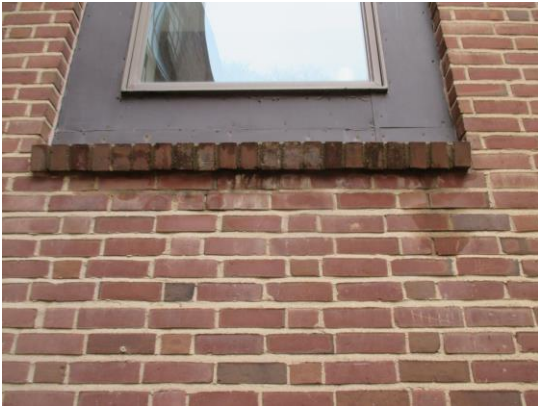
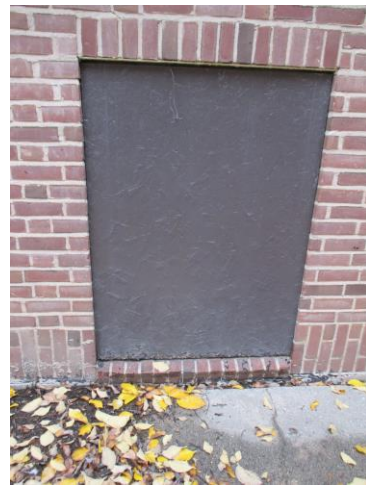
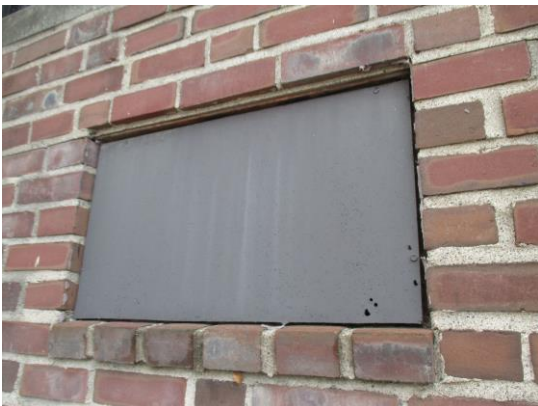
1. Many large openings have been infilled with studs and smaller windows (probably during 1970's). The exterior finish is metal clad panels with exposed fasteners. The joints of the panels have opened up and the fasteners have started to rust. Recommend replacing the panels with a concealed fastener system and caulk perimeter.
2. Other openings have just been infilled with painted wood panels that are not meant to be an exterior finish and many do not have sealant. Recommend covering with appropriate exterior finish (like a metal panel) and seal perimeter.
3. Ultimate solution would be to infill existing openings with aluminum system to match previous replacements.

A17: Existing Window Exterior

A18: Infilled openings

A19: Infilled opening

A20: Infilled opening.

A21: Infilled opening

A22: Infilled Opening

A23: Infilled Opening

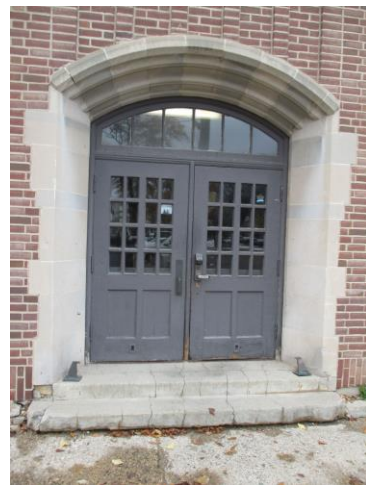
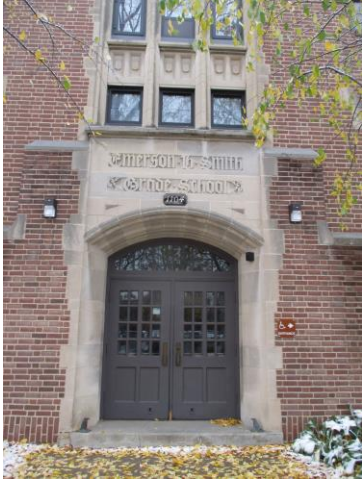
1. Doors and frames are showing signs of deterioration, especially along the bottoms. These appear to be original to the building and for the age, are in relatively good condition and could be repaired if desired.
2. Access door to basement on west side courtyard should be replaced and repair opening in wall.

A24: Entry Door

A25: Entry Door

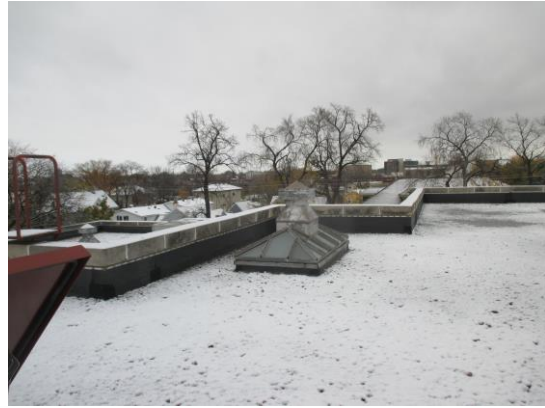
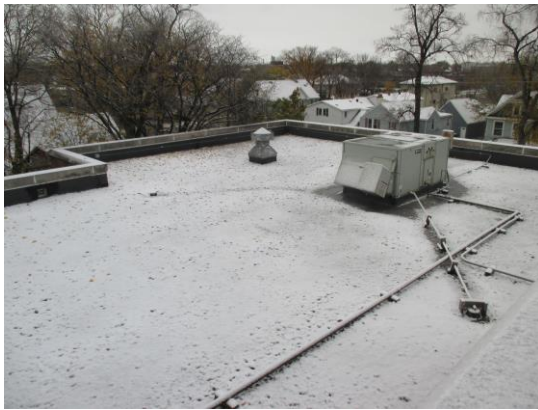
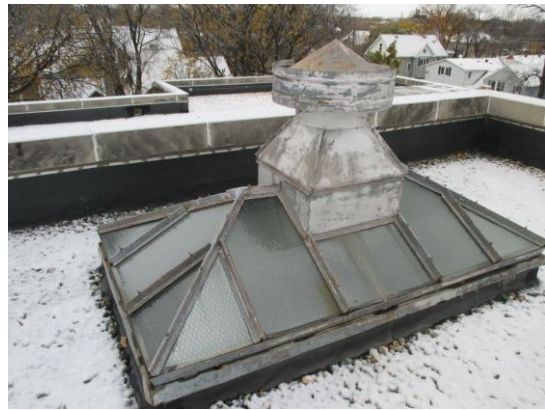
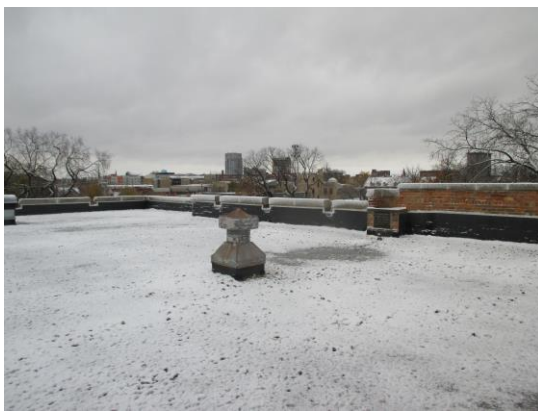
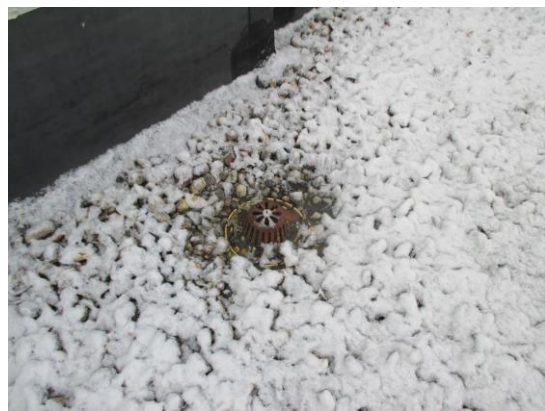
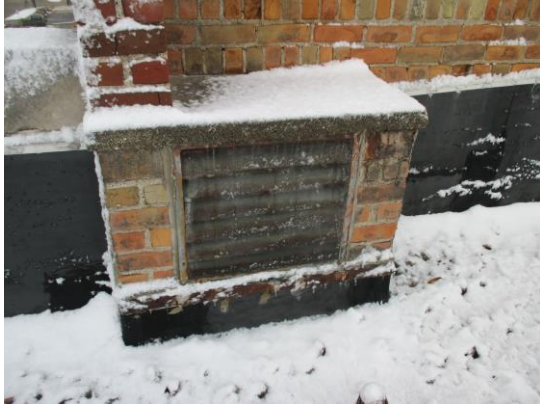
1. Surface was unable to be observed and no recent records were provided.
2. Tern bar and sealant along back of parapet seemed to be in good condition without deterioration or damage.

A26: Ballasted Roof.

A27: Gym Roof

A28: Skylight

A29: Upper Roof

A30: Roof Drain

A31: Ventilation louver

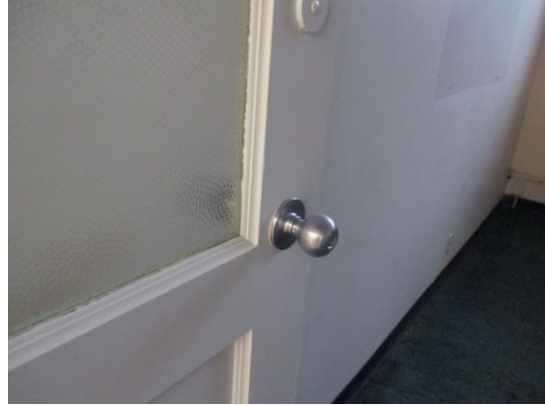
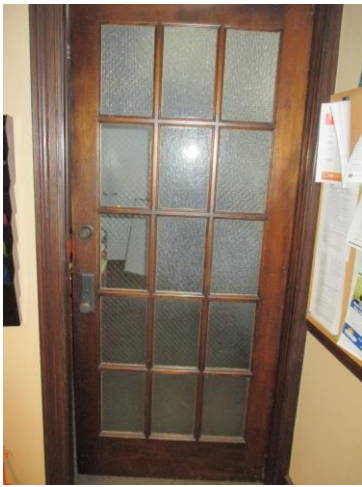
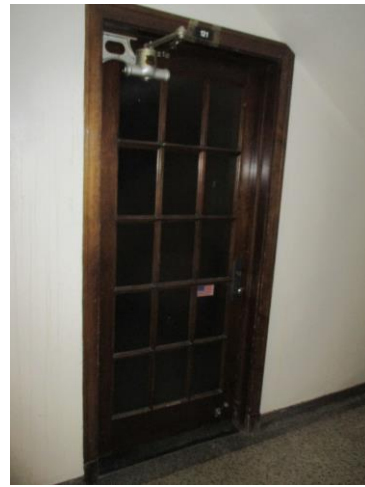
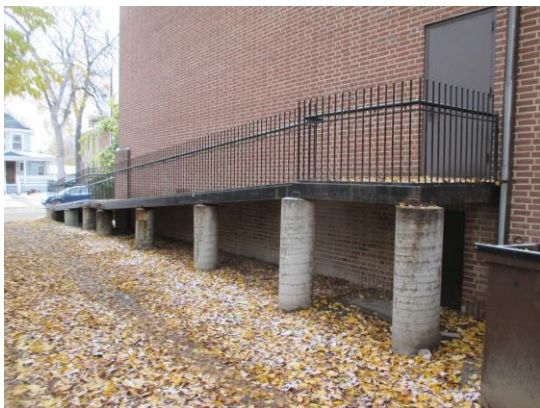
1. Accessible route to the building was added in 1996.
  - a. Includes an exterior ramp and elevator at the north entry. This is the only wheelchair accessible entry to the building.
  - b. An exterior egress ramp was also included for egress from the gymnasium on the west side.
  - c. Other entries to the building are only accessed by exterior steps without landings.
2. Panic hardware was added to select doors for updated egress.
3. Most door hardware consists of knobs and/or deadbolts that do not meet current ADA requirements.
  - a. Recommend changing out locksets to lever type.
4. Public restrooms fixtures have been modified for accessibility.
  - a. Further review needed if door configurations meet requirements. Minor adjustment is needed.
5. All current single use restrooms do not meet requirements.
  - a. Extensive remodeling would be necessary to bring up to ADA standards.

A32: Door Hardware.

A33: Door Hardware

A34: Door Hardware

A35: Exterior Ramp

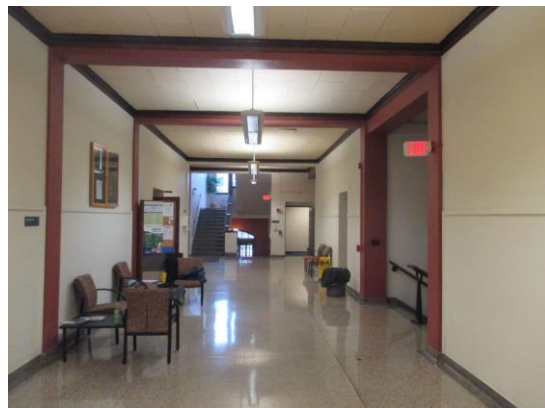
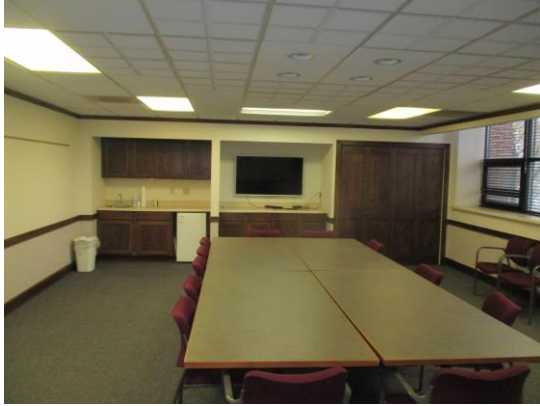
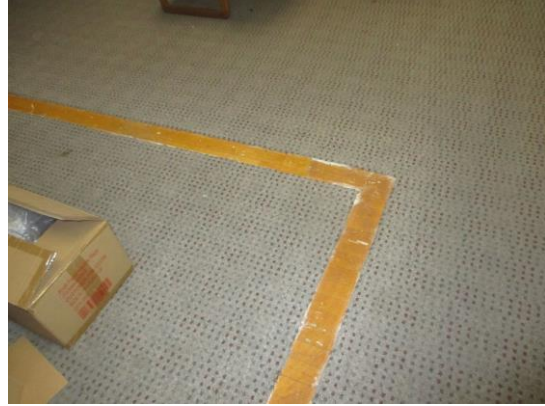
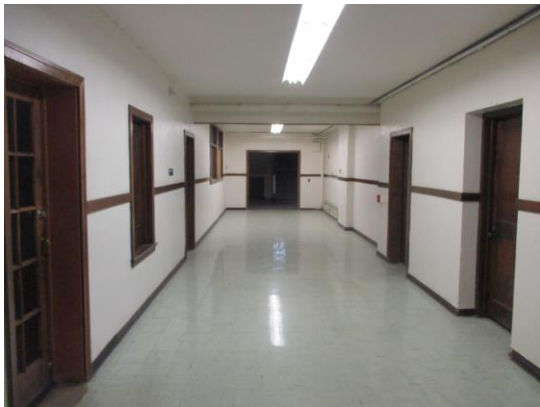
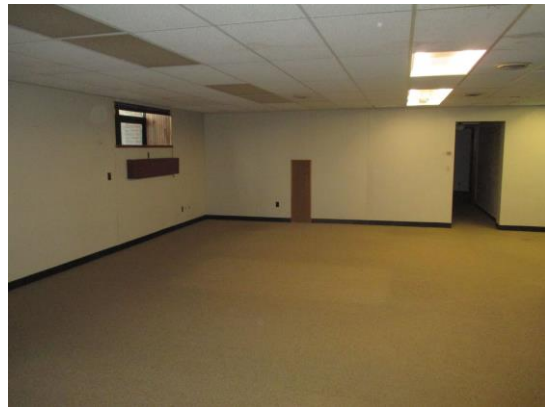
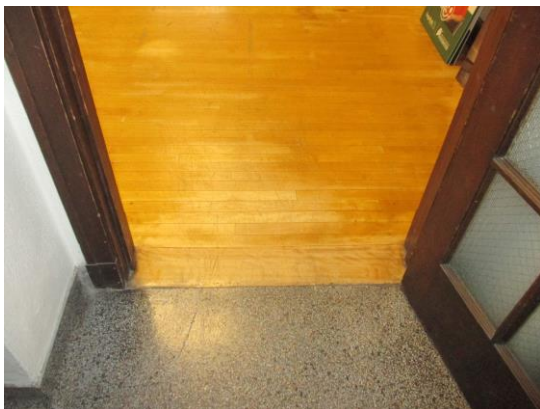
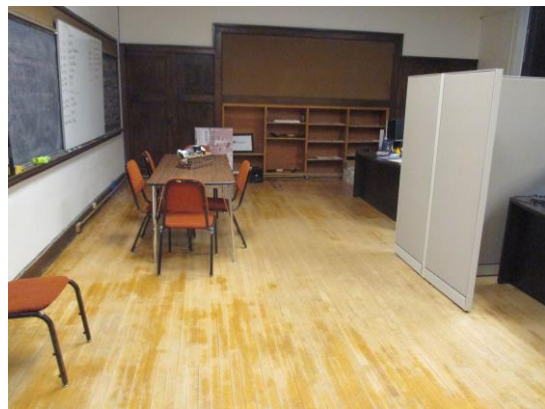
1. Existing corridor and restroom floor finish is terrazzo (probably sandbed type) with a coved base.
  - a. Very good condition – no outstanding cracks noticed.
2. Wood floors – primary classroom areas have wood floors.
  - a. Many office areas have installed carpet over this.
  - b. Where exposed appears to be in good condition and could be refinished.
3. Carpet
  - a. Where installed – appears to have reached the end of useful life and should be replaced.
4. VCT
  - a. Primarily in Lower level corridor – Good condition.

A36: Corridor Finishes

A37: Remodel Spaces

A38: Carpet over wood flooring.

A39: Basement Corridor

A40: Basement space

A41: Transition terrazzo to wood

A42: Wood Floor

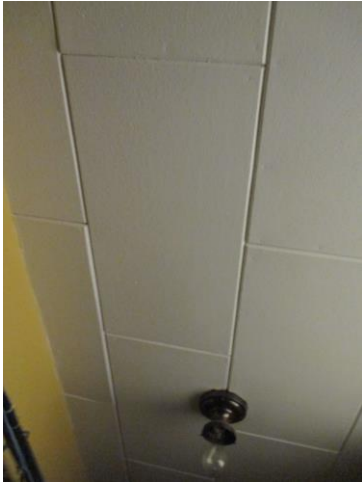
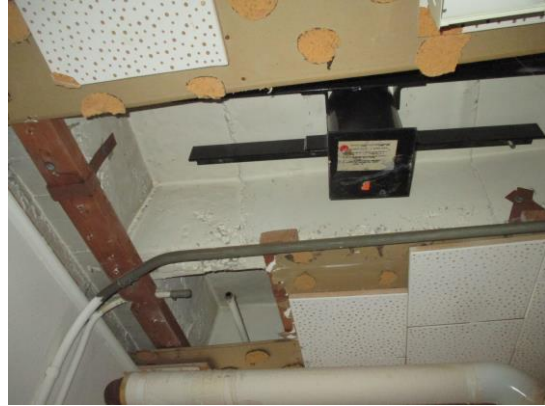
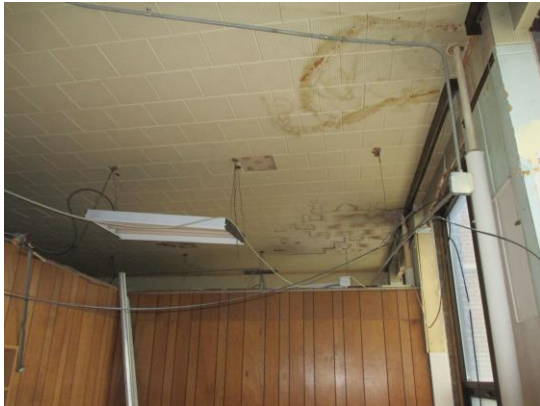
1. There are a variety of ceiling materials throughout the building.
  - a. Includes Lay-in tiles and grid, 12x12 spline tiles (adhered), 1x2 adhered tiles and plaster.
    - i. The plaster appears to be in good condition without evidence of any major repairs.
    - ii. Lay-in tile and grid may appear dated, but otherwise in good condition.
    - iii. There are multiple versions of the 12x12 spline tile. Most are above other ceilings and the primary damage is from removal – substrates in good condition.
    - iv. 1x2 adhered tiles have a smooth texture and only show damage in a couple of areas.
  - b. Cosmetic changes would only typically be needed for uniform appearances.

A43: 1x2 adhered ceiling tile

A44: 12x12 ceiling tile.

A45: 12x12 ceiling tile

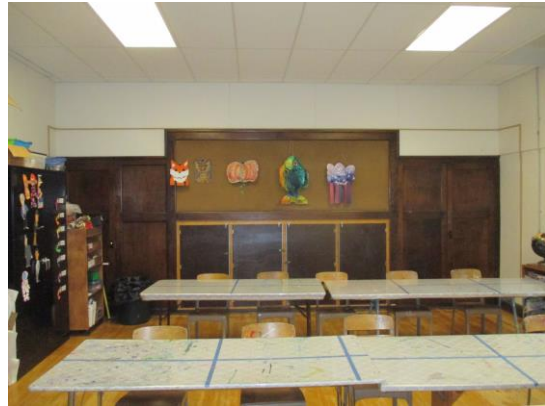
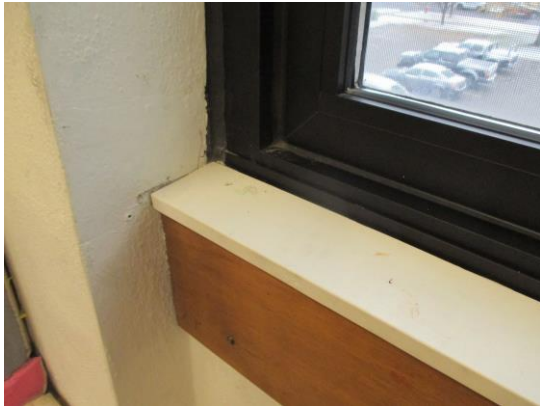
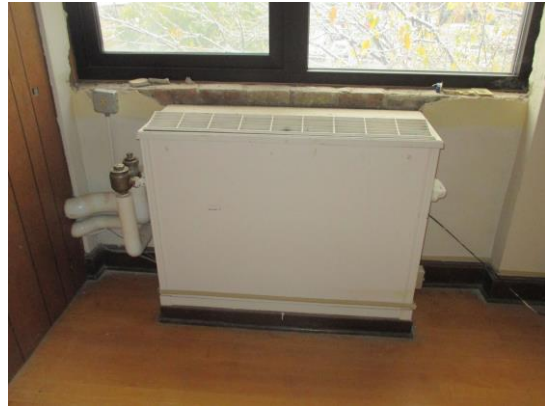
1. There are a variety of wall materials throughout the building.
  - a. Includes Plaster, wood paneling and gypsum wallboard.
    - i. Like the ceilings – plaster appears in good condition.
    - ii. Paneling is located primarily on walls that were constructed within original classrooms. Would only need replacing with remodeling.
    - iii. The Gypsum wallboard appears to be in good condition without evidence of any major repairs.
  - b. Walls at replaced windows on level 2 (east side) should be repairs to provide finished appearance.
2. Wood Trim
  - a. There is a significant amount of wood trim along corridors and within existing classrooms. Most are in very good condition.
  - b. Trim at replaced windows does not match existing or even at other replaced windows.

A46: Existing classroom casework

A47: Trim at replaced window

A48: Unfinished sill at replaced window

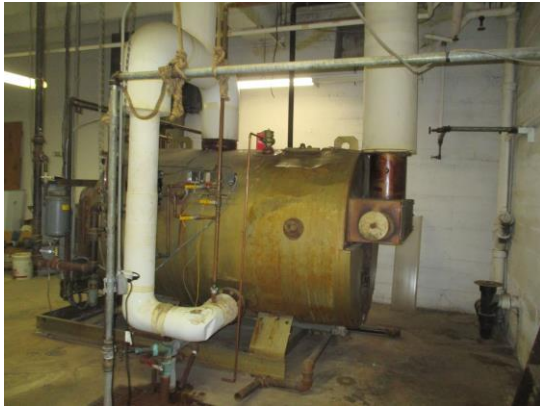
1. Boiler (1968) was recently refurbished and is in good condition. No replacement needed.
  - a. Natural gas fuel.
  - b. Steam feeds existing radiators.

A49: Boiler

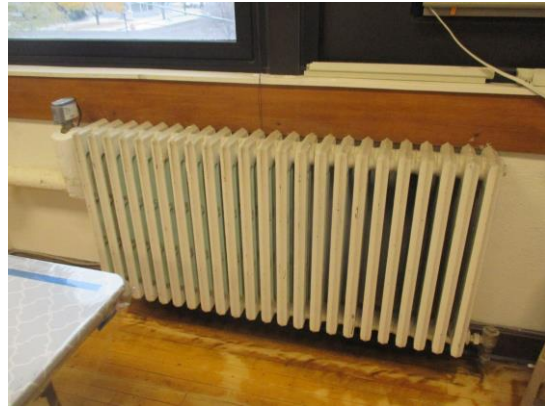
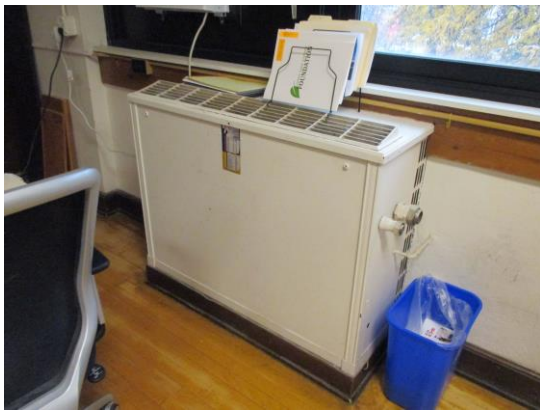
3. Primary heat in spaces is provided by steam radiators (there are still some unit ventilator units with outside air closed off).
  - a. Consider changing to hot water for better control.

A50: Steam Radiator.

A51: Ventilator Radiator

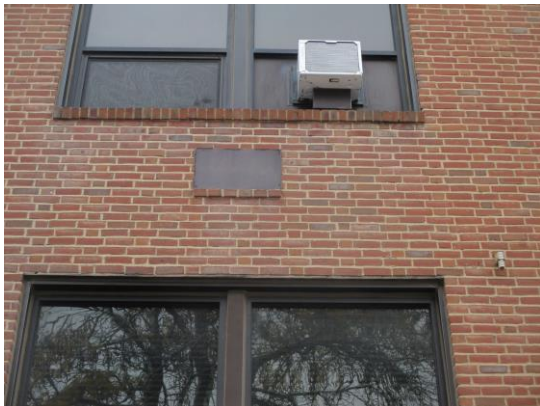
5. Many spaces are cooled only by means of window A/C unit.
  - a. Recommend adding a central chilling plant or review systems that could provide better access to cooled air if spaces are fully occupied.

A53: Window A/C unit

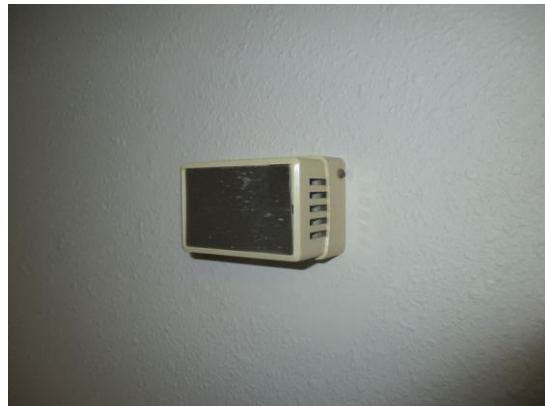
6. Temperature control is currently a Pnuematic system.
  - a. This type is getting harder to service and repairs can be expensive.
  - b. Consider replacing with DDC system for better control if using a building automation system.

A54: Pneumatic wall control

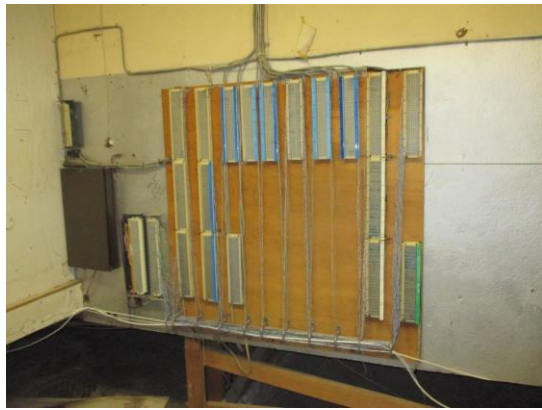
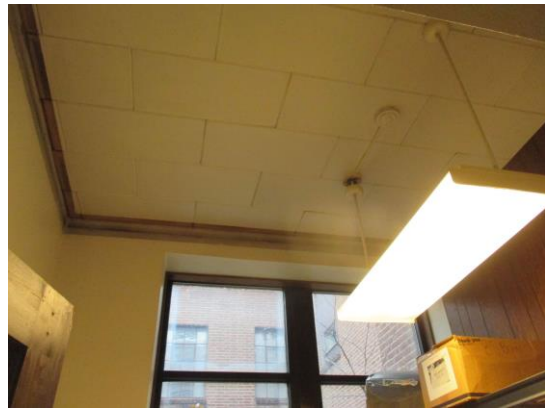
1. Service is adequate for existing needs.
  - a. Needs review if any other mechanical systems were brought online.
2. Lighting
  - a. Existing lighting is primarily Fluorescent. If remodeling – Provide LED.
3. Telecommunications
  - a. Extensive analog telecommunications system installed. Should upgrade to all digital.
    - i. May require a dedicated data room.

A55: Analog telecommunications panel

A56: Lighting.
